## AVIATION INVESTIGATION REPORT

A02O0123

### CARGO BAY FIRE

BOEING 767-300 C-GHML

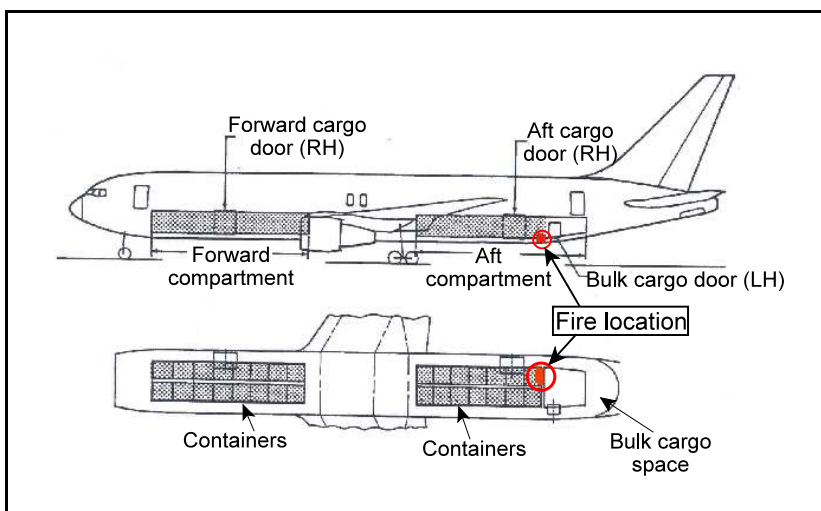
When the cargo doors were opened, smoke and fumes flowed out of the compartment. The firefighters entered the compartment with a handheld FLIR camera and located a single heat source behind the aft wall of the cargo compartment (see Figure 1). Maintenance personnel removed the aft wall, and the heat source was identified as a recirculating fan. With no other indications

Figure 1. Fire location

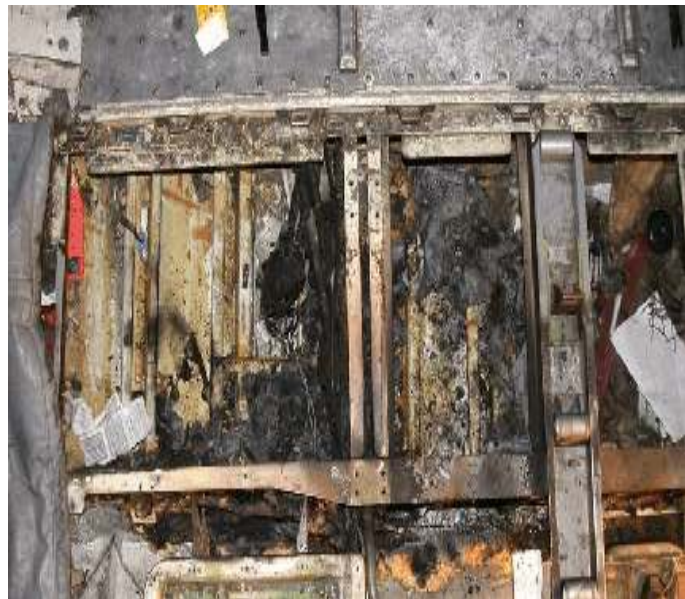
The fire was located below the floor level of the aft cargo compartment in an area defined longitudinally by fuselage station (FS) 1385 and FS 1412 and laterally by left buttock line<sup>3</sup> (LBL) 6 and right buttock line (RBL) 50. The fire burned holes through the structural floor beam web at FS 1395, and consumed the thermal acoustic insulation on both sides of the floor beam. Also damaged were the underside of the floor board between RBL 22 and RBL 44, potable water lines, heater ribbons, and associated electrical wiring (see Photo 1).

Photo 1. Fire-damaged area

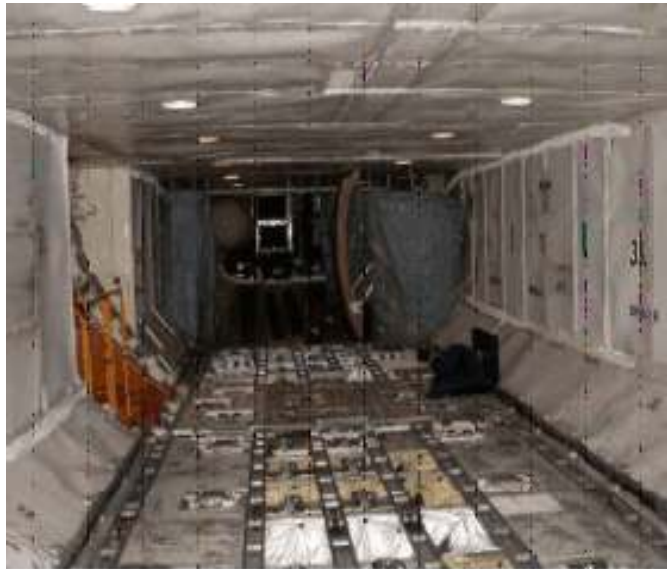
Photo 2. Aft cargo compartment

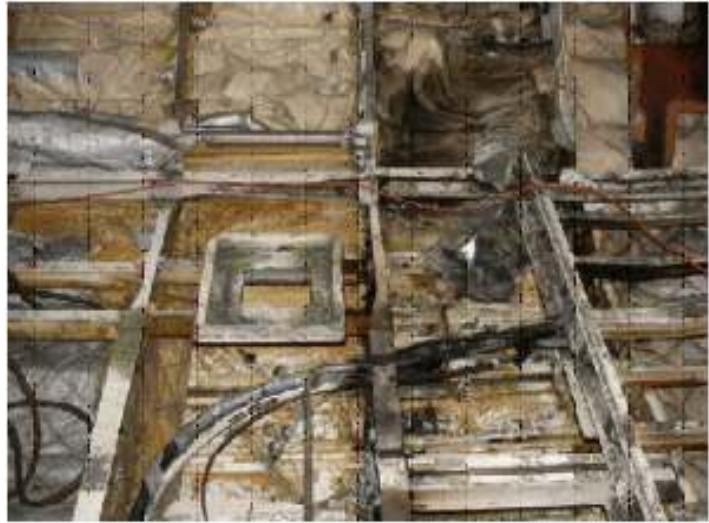
The Electrofilm brand heater ribbon failed aft of FS 1395. The heater ribbon was laid longitudinally along the water line and over the repair site. The heater ribbon overheated and arced at the forward edge of the repair, where the original water line ended and the stainless steel began. This resulted in the heater ribbon burning through the protective tape and the Rubatex foam insulation. Because electrical power was still being provided to the heater ribbon, the failure continued to move forward along the water line toward the source of electrical power.

Photo 3. Fire-damaged area

Approximately eight inches forward of the failure, where the water line passes through the FS 1395 floor beam web, the thermal acoustic insulation blanket mounted on the forward and aft face of the vertical web of the floor beam ignited. At this point, the fire became self-propagating and moved forward as far as FS 1385, aft as far as FS 1412, left as far as LBL 6 and right as far as RBL 50 (see Photo 3).

The fire burned miscellaneous debris and partially consumed the insulation blankets on the forward and aft face of the FS 1395 floor beam and the insulation blanket lining the bottom of the pressurized hull. As well, the fire damaged the underside of the floor board between RBL 22 and RBL 44. It breached the cargo compartment liner at RBL 44 and progressed behind the right sloping sidewall to RBL 50. The undersides of the two baggage containers loaded directly above the fire were scorched and blackened with soot, but showed no signs of damage. There were no reported claims of damage for any of the associated luggage or cargo. Externally, the fuselage paint directly below the fire location was blistered.

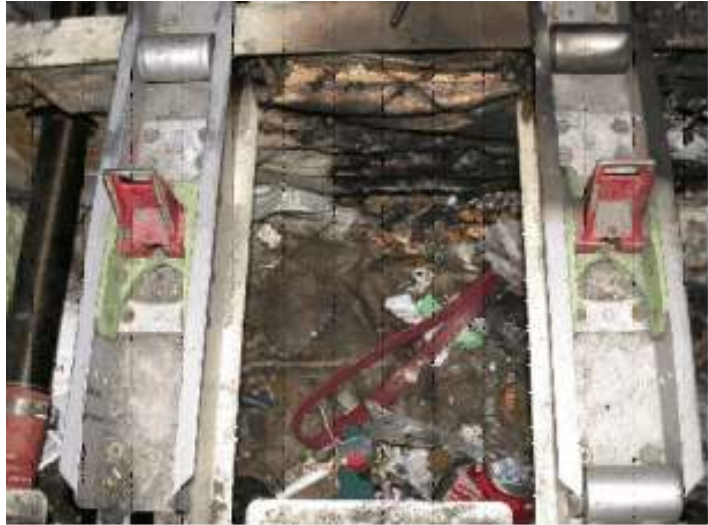
Contaminated thermal acoustic insulation blankets in the vicinity of the heater ribbon provided fuel for the fire. The contamination consisted of soiled insulation blankets and of flammable debris in the form of paper, candy wrappers, Styrofoam packing peanuts, small polyethylene beads, and rubber powder from a PDU (see Photo 4). Samples of the burnt PET-covered insulation blankets were analyzed for the presence of fire accelerants. An isoparaffin solvent was detected. These types of solvents are often clear combustible liquids that readily form

Photo 4. Contaminated insulation blankets and debris

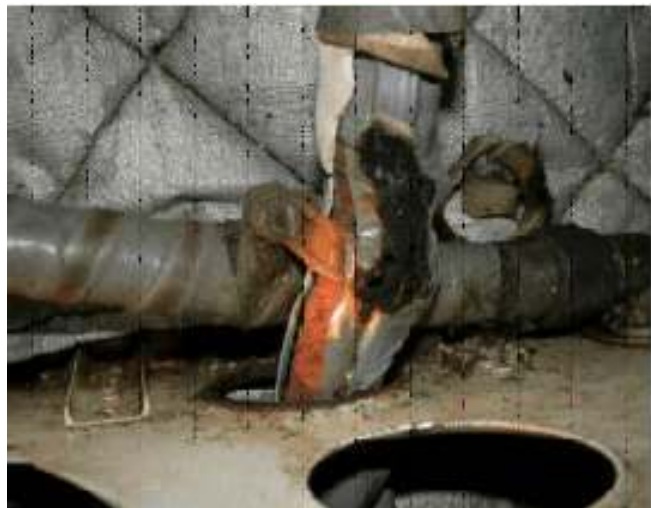
In addition to the fire damage associated with the occurrence flight, TSB investigators found a burned Cox & Company heater ribbon, protective tape, and Rubatex foam insulation behind the aft wall of the aft cargo area on the occurrence aircraft (see Photo 5). Although a self-propagating fire had not occurred, the area had become hot enough to burn through the Rubatex foam insulation and a nearby plastic clamp.

Photo 5. Burned heater ribbon behind aft wall

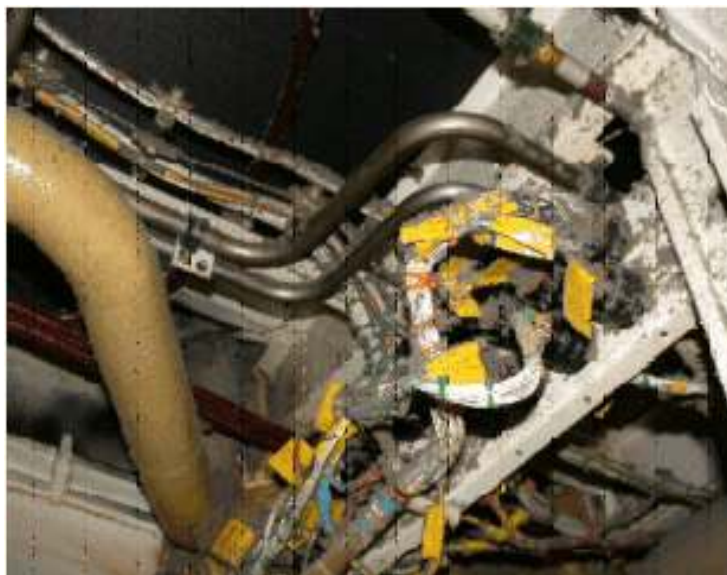
Photo 6. Dust and lint accumulation on wiring bundles behind wall panel

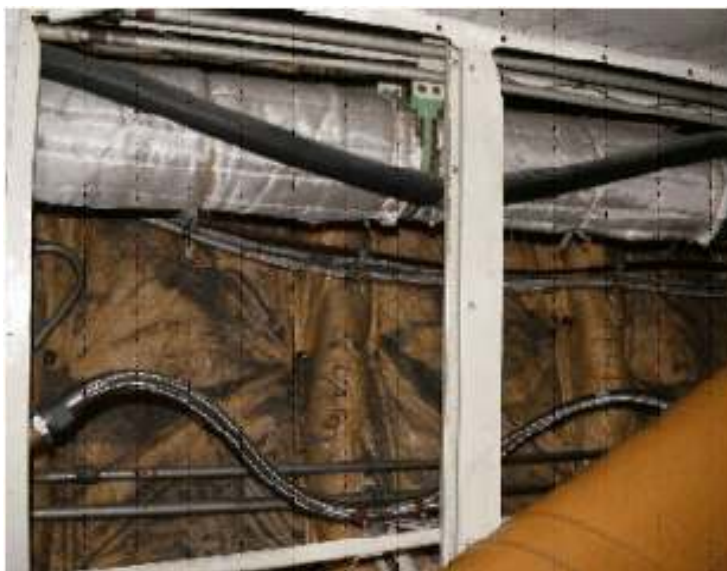
Photo 7. Dust and lint accumulation on thermal acoustic insulation behind wall panel
